CROW CPX Round Robin Test 2020

Title Results
CROW CPX Round Robin Test 2020

Report No. M+P.CROW.20.01.1

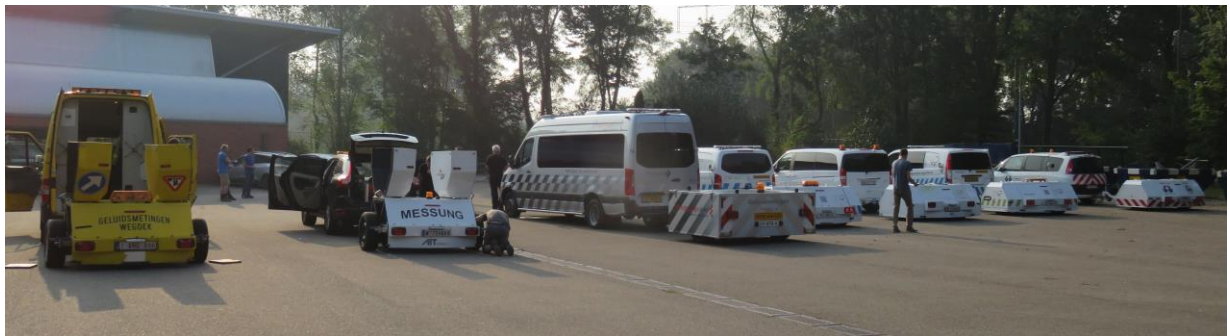
In total eight CPX-systems participated in the CPX round robin test on September 16th, 2020. In figure 1 a photo of the measurement systems is shown. Seven CPX-trailers have an enclosure and one had no enclosure. Below also pictures are shown of the CPX-trailer of each participant. Names and addresses of the participants are listed in Appendix A.

*CPX-measurement systems that participated in the round robin test 2020
(left to right: Vlaamse Overheid, AIT, OMWB, M+P (trailer 02), G+P, M+P (trailer 04) and BRRC).
Not in the figure CPX-system of DGMR*

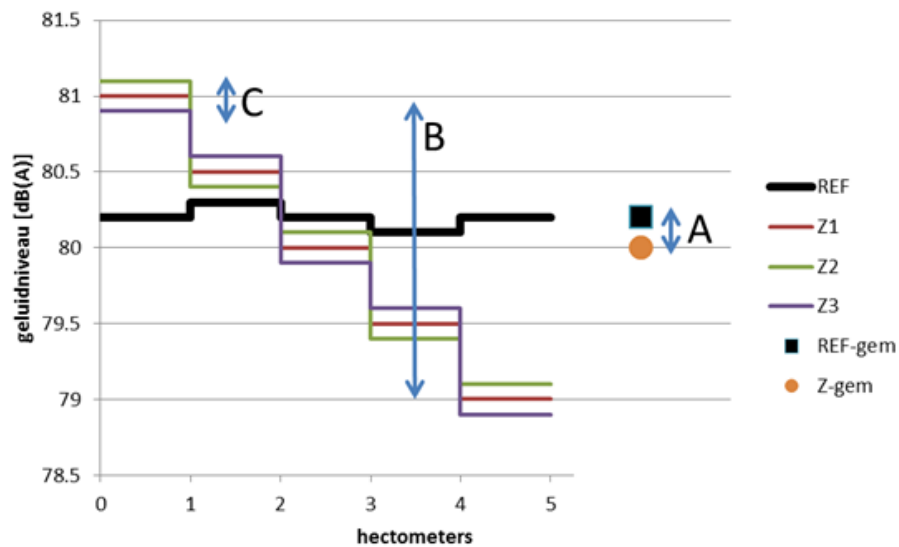
The parameters 'A', 'B' and 'C' quantify the spread in measurement results and are used to check the compliance with the protocol. A fictive example of measurements over a length of 500 m is shown in figure 2. The black line represents the group average per 100 m section (hm-section). The other lines indicate the results of three measurement runs performed by one measurement device "Z". Other measurement devices are not shown. In this example the device Z has a small average difference with respect to the reference (small 'A'), but relatively large variation in differences with respect to the reference (large 'B'). The variation is not caused by accidental variations between repeated measurement runs, because this variation is smaller (small 'C').

figure 2 Explanation of A,B and C parameters in CPX protocol round robin test

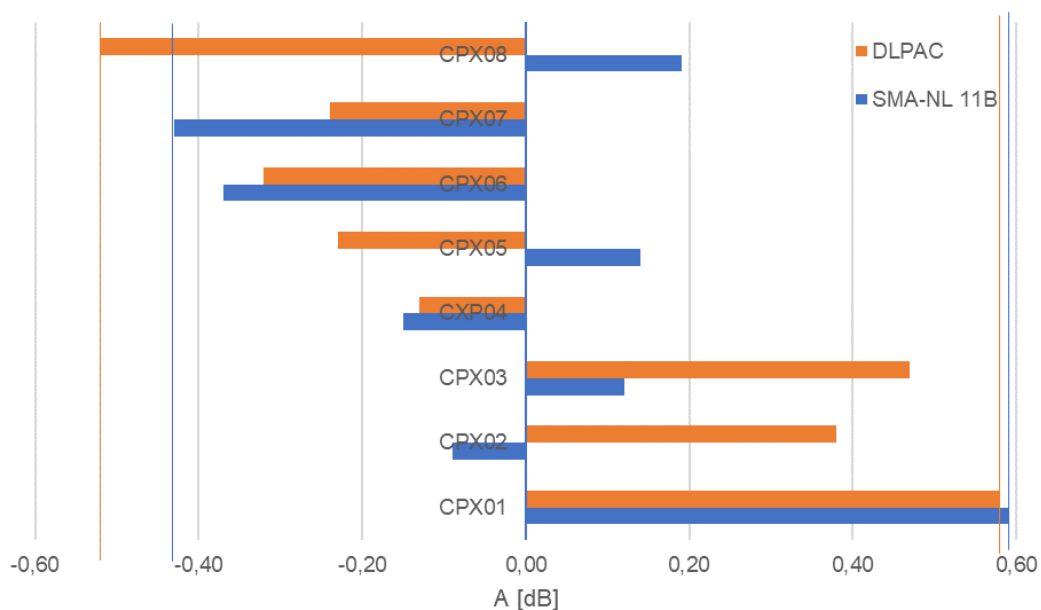
The results of determination of the parameters 'A', 'B' and 'C' are shown in table I. To be able to see the differences between the CPX-systems in more detail the value of the parameter 'A' is not presented as an absolute value as required according to the protocol.

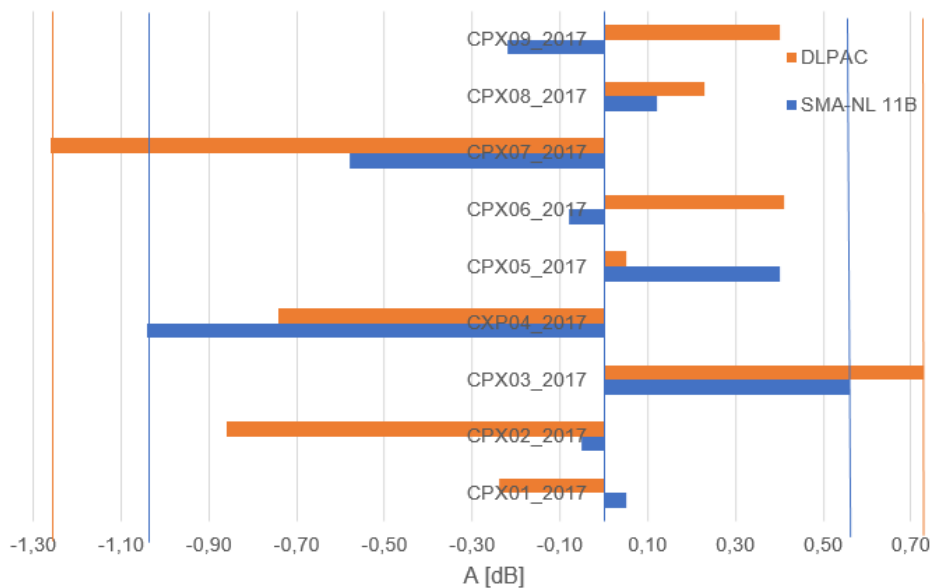
table II Results of the CROW CPX RRT in 2017 including tyre rubber hardness correction
